## Application Solutions - Automotive Industry

### ***Flange Flaw Detection With Smart Measurement Sensor***

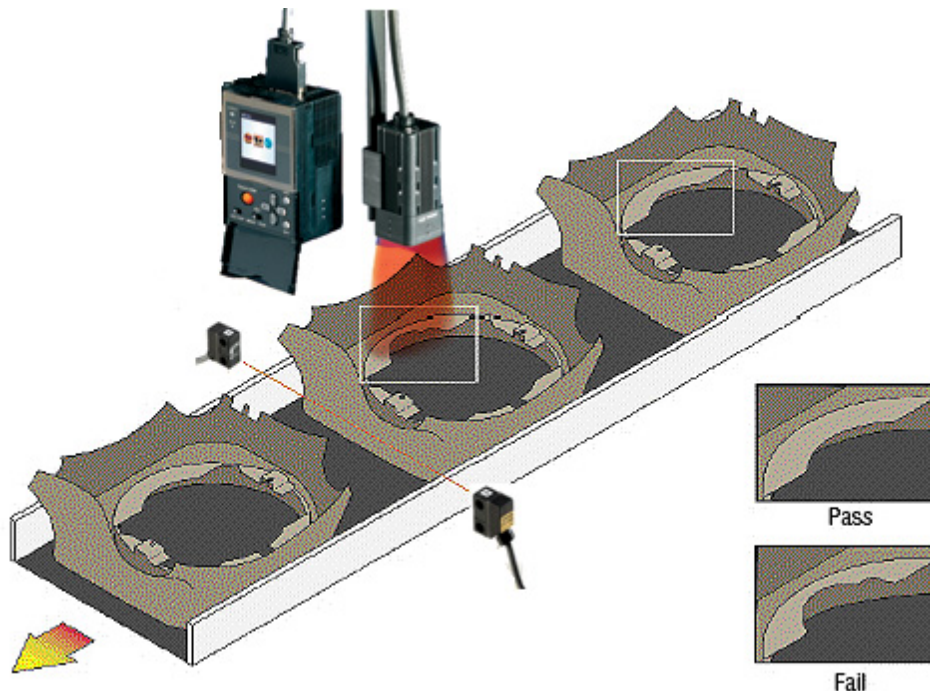
***Solution:*** The ZFV sensor inspects each molded plastic component for irregularities in a flange area by using pattern matching. The sensor rejects any parts that contain flaws. The easy-to-teach sensor can store several model images to shorten changeover time between production runs. Also, an E3C through-beam sensor triggers the inspection. It's miniature sensing heads and separate amplifier make it ideal for space-confined inspection sites.

***Challenge:*** A molded plastic steering column component must be 100% inspected before acceptance for assembly. Sometimes the mold fails to fill completely or a portion of the internal flange tears when the mold releases. The flange provides critical sealing and noise dampening in the finished steering column.
